December 9, 2024

SUBJECT: Hydrogeologic Investigation at the Former Maine Gravel Services Pond Site

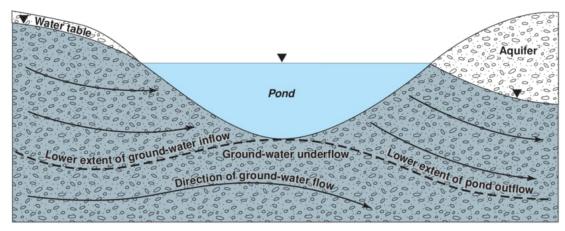
Given these conditions, the pond-aquifer interaction at the Site is characterized by a flow-through condition in which groundwater discharges into the pond in upgradient areas and surface water in the pond recharges the sand and gravel aquifer in downgradient areas, as illustrated in the diagram in **Photo 4**.

Photo 4 – Interactions between groundwater flow through a pond and the surrounding aquifer in an unconfined hydrogeologic environment. Source: WRI Report 99-4174.
